TECHNICAL REPORT NO. 4-61

**EVALUATION OF THE DYNAFLECT
FOR THE
NON-DESTRUCTIVE TESTING
OF
PORTLAND CEMENT CONCRETE PAVEMENTS**

by
GEORGE M. PACE

**DEPARTMENT OF THE ARMY
OHIO RIVER DIVISION LABORATORIES, CORPS OF ENGINEERS
CINCINNATI OHIO, 45227**

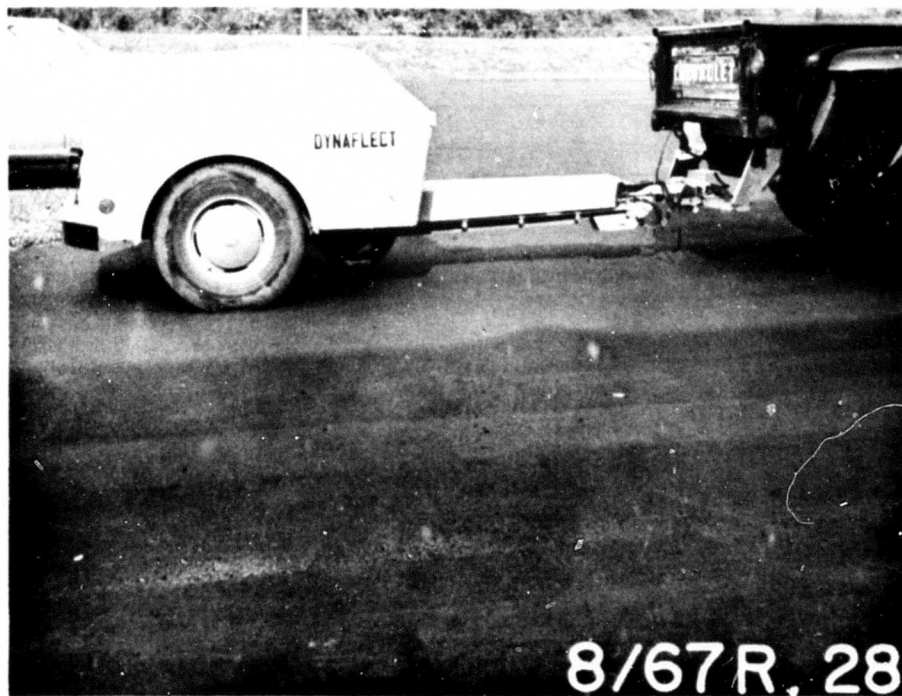
a. View of Dynaflect in Road Travel Position
